Hot corrosion Evaluation of Carbon Steel caused by Mixtures of Vanadium Oxide and Sodium Sulfate Simulating Ashes of Fuel Oils

Fernando B. Mainier¹, Alexandre Santos de Oliveira²

Escola de Engenharia, Universidade Federal Fluminense, Niterói, RJ, Brazil.

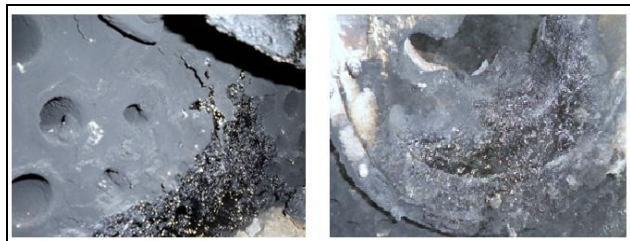
This type of corrosion has been observed in the inspections carried out on the carbon steel tubes of fire-tube boilers located in the furnace area (Figure 1). It is believed that this corrosion is associated with the burning of fuel oils.

Fig. 1: Hot corrosion aspect of a fire-tube boiler

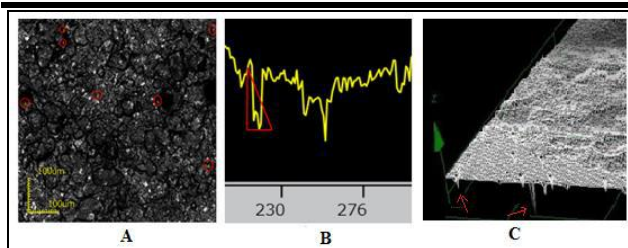
As shown in Figure 3, the pitting are identified by red circles in the micrograph, and by means of proprietary software installed in the confocal optical microscope, a rectangle triangle is generated that determines the depth of each pitting as shown in the 3D image.

Fig. 3: A) Identification of pitting the micrograph; B) Profile of pitting with depth; C) Pitting in 3D.

In the evaluation of pitting corrosion, the concepts of the ASTM standard G46-94 [10] were used while measuring the deepest pitting and expressing the degree of corrosion in terms of maximum depth or the mean of the 10 pitting with the highest penetration.

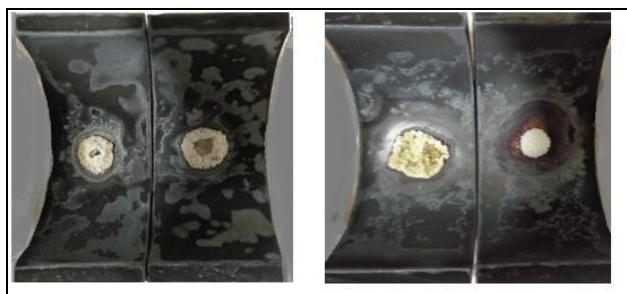
Figure 4 shows the appearance of the coupons after removal from the electric furnace. Considering that the fluxing mass (Na_2SO_4 and V_2O_5 mixture) was placed at the center of the cane-shaped coupon, it has been observed that the corrosion was localized and more intense, resulting in a depression and localized mass loss of carbon steel. Furthermore, the appearance of the molten mixture has also been observed.

Fig. 4: Appearance of the coupons after removal from the electric furnace

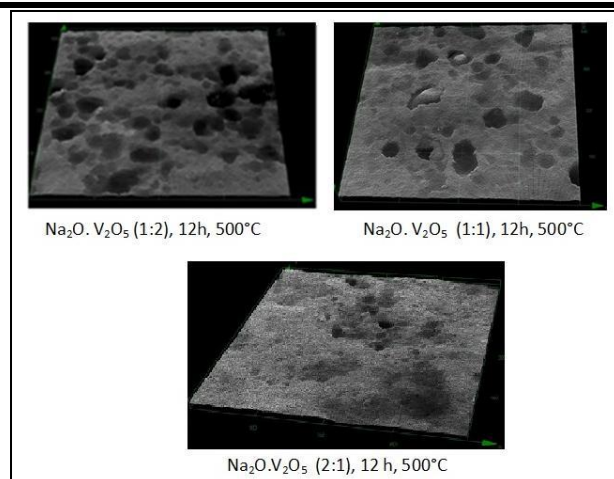
In the micrographs shown in Figures 5, grooves, excavations, pitting and uniform corrosion on the surface of the exposed coupons at 500°C with mixtures of Na_2SO_4 and V_2O_5 were observed. Additionally, these observations were mentioned in the research studies conducted by Lai [11] and Khadom [12] as a characteristic of the dissolution of the oxidation film.

Fig.5: Aspect of surfaces in 3D after the tests at 500°C and 12 h of exposure.

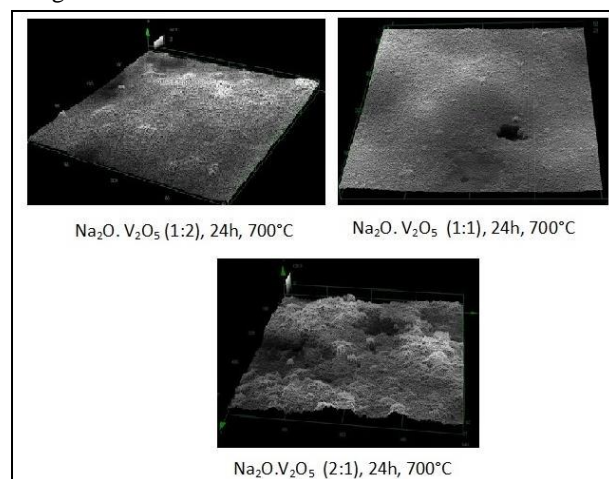
As the temperature increases from 500°C to 700°C and then to 800°C , there is a transformation of the corrosion located in uniform corrosion and consequently, there is a greater loss of mass of the carbon steel coupons as shown in Figures 6 and 7.

Fig. 6: Aspect of surfaces in 3D after the tests at 700°C and 24 h of exposure.

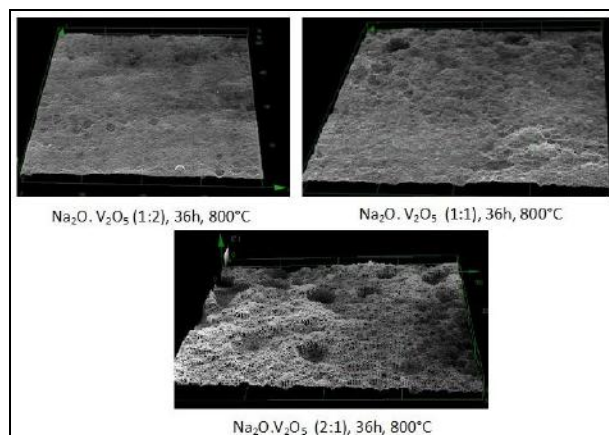
Fig. 7: Aspect of surfaces in 3D after the tests at 800°C and 36 h of exposure.
